First clinical experience with „crown abutments“ for single tooth restorations

J. de San José González[^], C. Mertens[°], H. G. Steveling^{*}

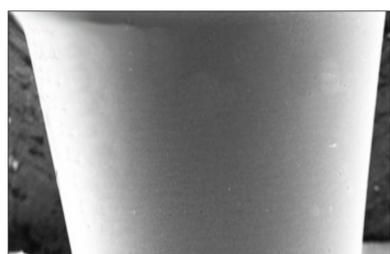
1.Original smooth zirconia abutment surface

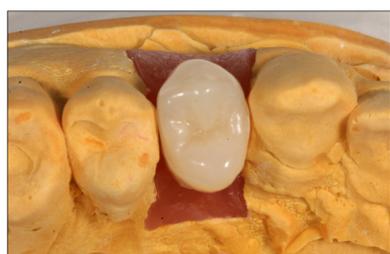
2.Wax-up occlusal view

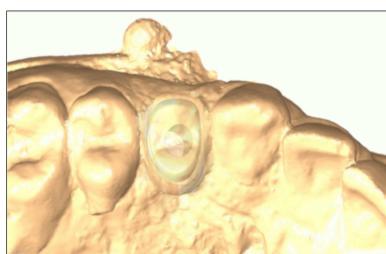
3.WebOrder occlusal image with wax-up

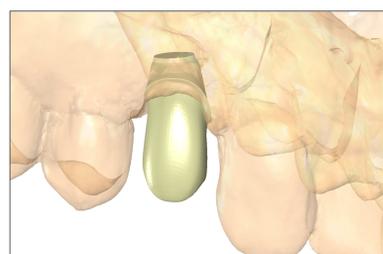
4.WebOrder buccal view

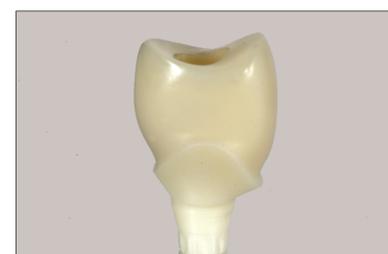
5.Crown abutment

Method: 15 crown abutments with different interfaces for the replacement for molars, bicuspid and one lateral upper incisor. Before the fixation of the screws all proximal contact points were checked. Access holes were closed with composites using the right shade. The crown abutment is directly screwed to the implant.

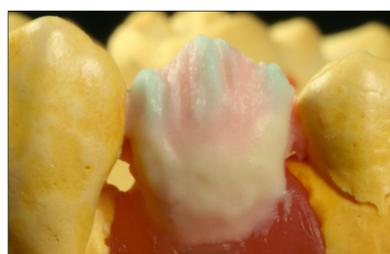
6.Ceramic facing

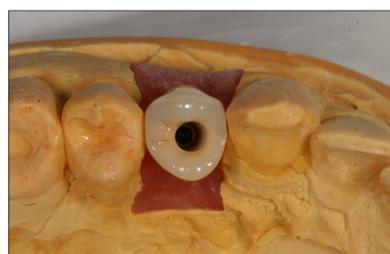
7.Final restoration occlusal access hole

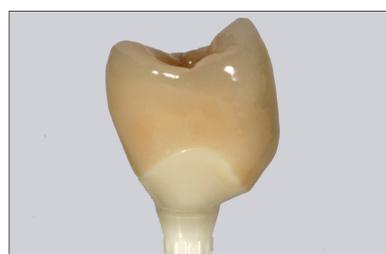
8.Crown abutment with ceramic veneer

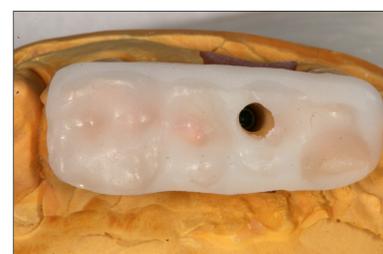
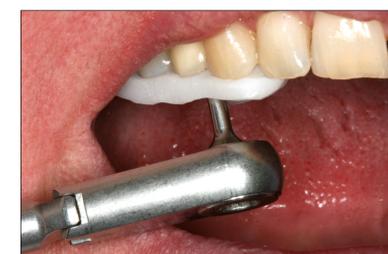
9.Screw in key

10.Screw in key

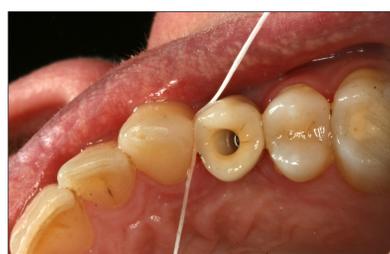
11.Check proximal contact point

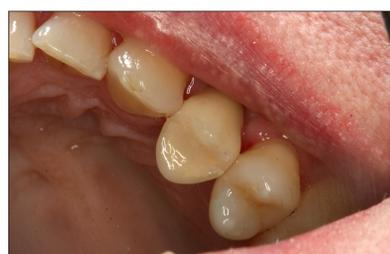
12. Close access hole composites

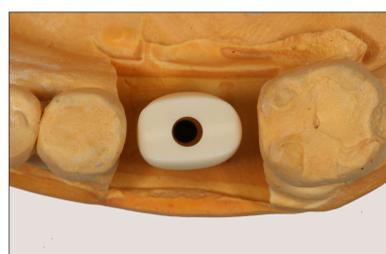
13.Crown abutment occlusal view

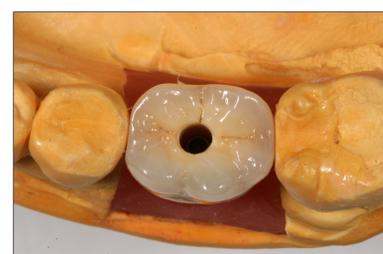
14.Final restoration

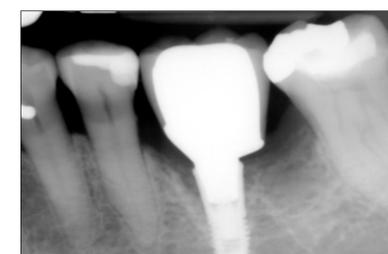
15.Intraoral X-ray

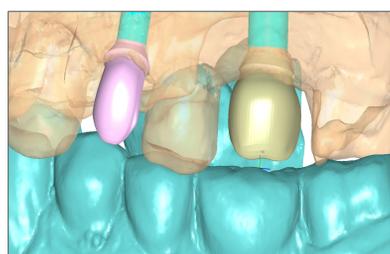
16.WebOrder buccal view

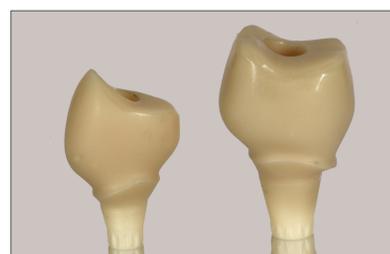
17.Crown abutments

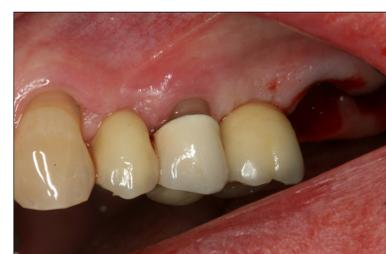
18.Final restoration

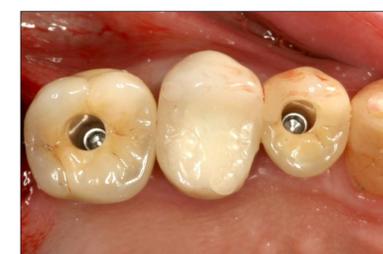
19.Final restoration occlusal access holes

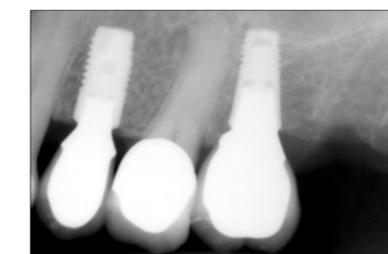
20.Intraoral X-ray
